SAMPLE - New Home Inspection Report

1234 Yourstreet, Your City, Arizona 85xxx

January 1st, 2008

NEW HOME FINAL INSPECTION PUNCH LIST - SAMPLE

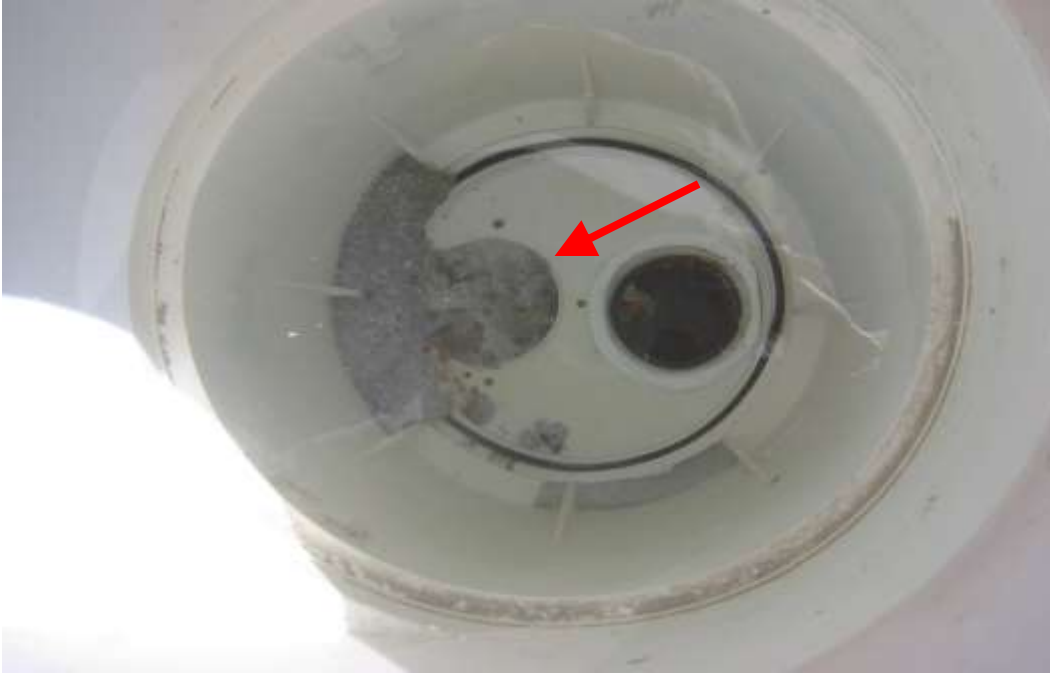
Picture 1

- There is concrete in one of the intake holes inside the skimmer basin (**See Picture 1**)
- There is no basket inside the skimmer.

Concrete in pool skimmer.

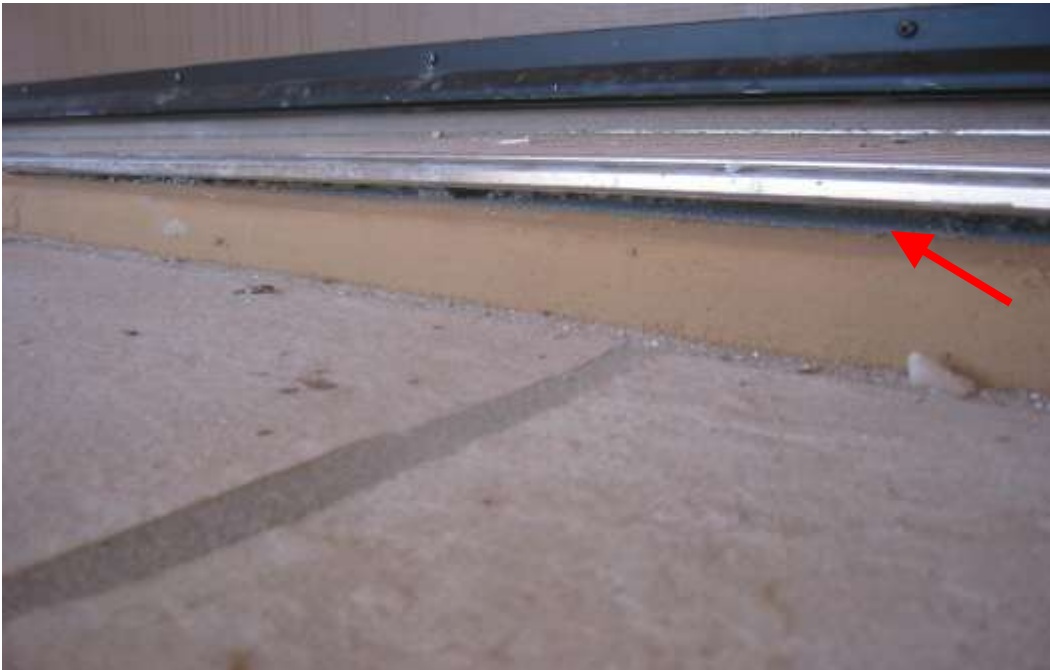
Picture 2

- There are gaps below several of the door thresholds that should be sealed (**See Picture 2**).
- There is a section of stucco repair outside the master bathroom (East wall) that should be redone (**See Picture 3**).
- There is a large section of stucco damage on the lower corner of the breezeway carport near the large garage door (**See Picture 4**) that should be repaired.
- The doorbell is loose.

Gaps below door thresholds.

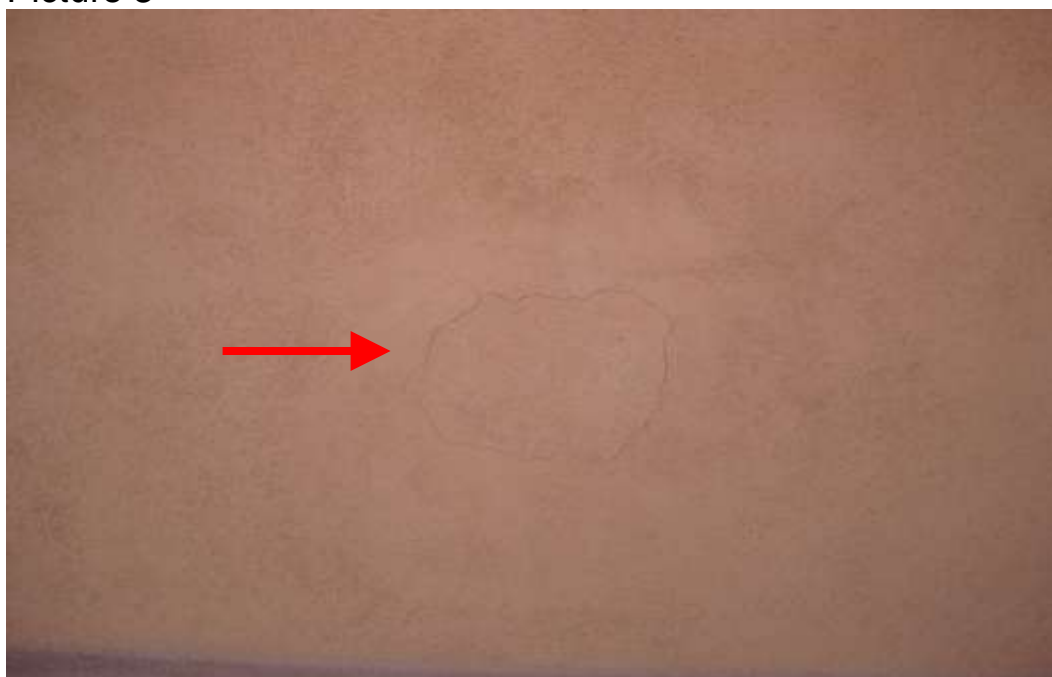
Picture 3

Work on stucco patch on East wall outside master bathroom.

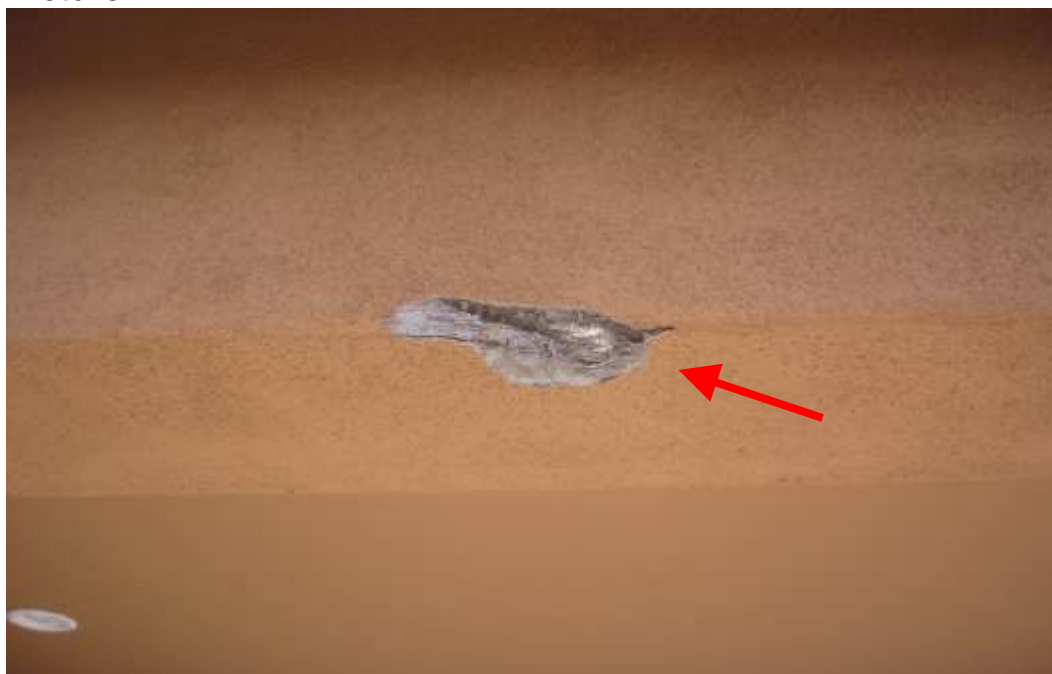
Picture 4

Stucco damage on lower corner of carport/breezeway.

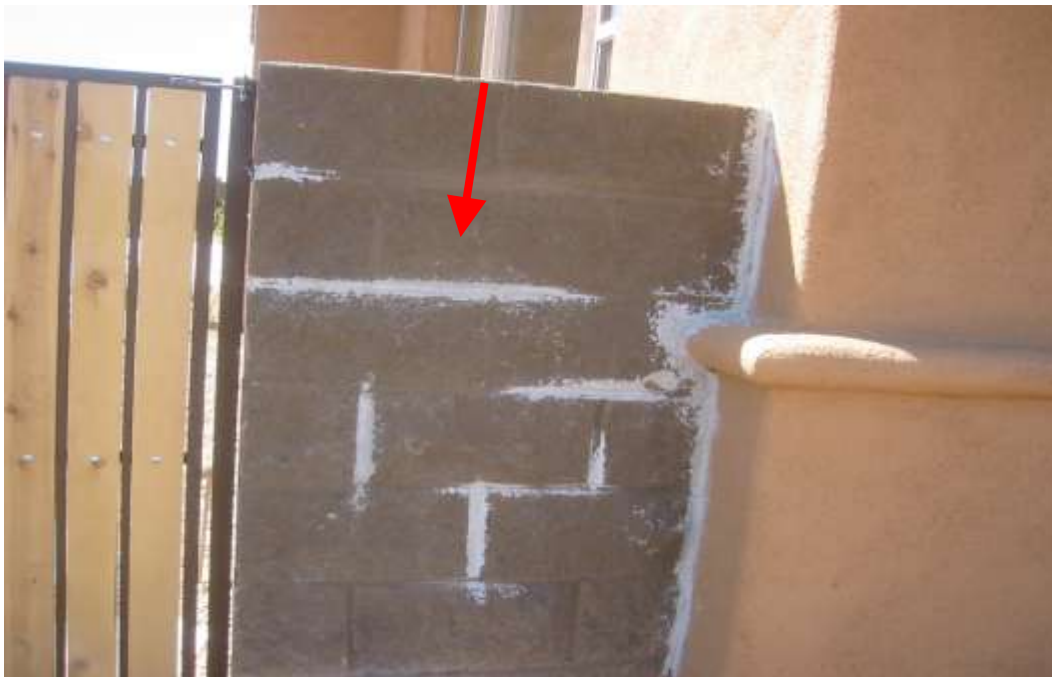
Picture 5

- There is tape residue on the frames of the master bedroom windows along the back wall.
- There is touch-up painting needed:
 - Around the entire back yard block fence/retaining wall (**See Picture 5**).

Touch-up painting needed on back yard block fence/wall.

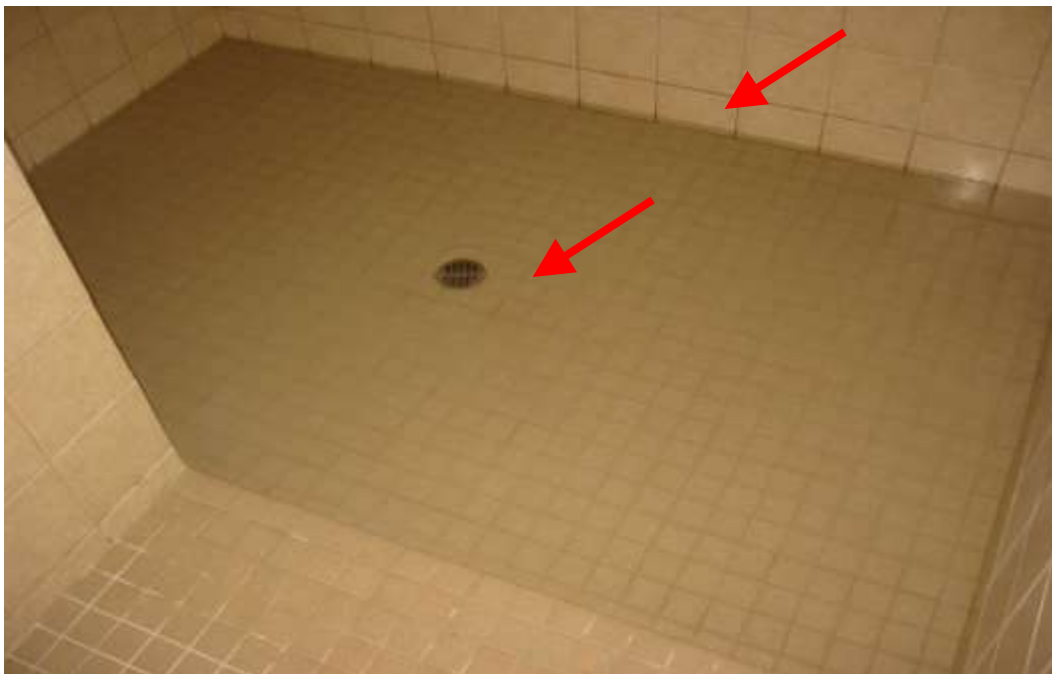
Picture 6

- There is a sewer/drainage issue with the house. We filled the master bathroom whirlpool tub in order to test the jets. When we began draining the tub we noted water backing up into the shower stall adjacent to the tub (**See Picture 6**). We put the drain stopper back down in the tub to prevent the shower stall from overflowing into the bathroom and continued with the inspection. Toward the end of the inspection we went into the corner (West) hallway bathroom and noted water on the floor (**See Picture 7**) but could not find the source of the water. On a hunch we went back into the master bathroom and pulled the stopper up in the whirlpool tub to drain the remaining water (about three inches). When we went back into the corner hallway bathroom water was backing up into the tub and apparently coming out from under the tub which would be indicative of a drain leak

Water in master bathroom shower stall from bath tub draining.

below this tub. Suggest further investigation and remedial action of these items as needed.

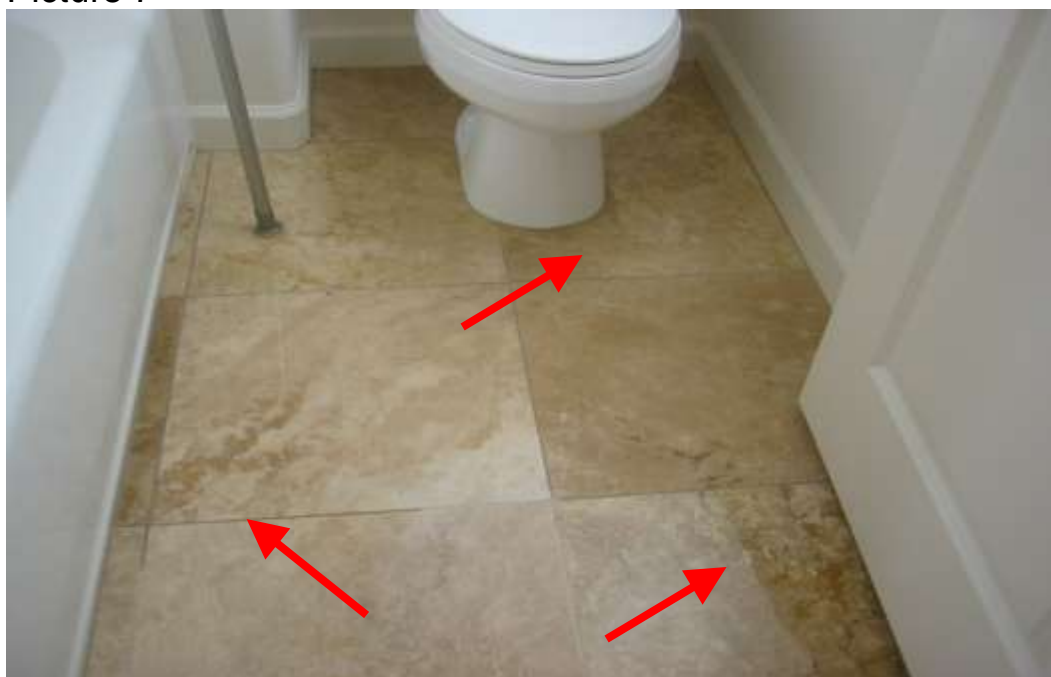
Picture 7

Note: due to the water in the hallway bathroom the carpet at the entry to the front hallway bedroom got wet. There was also standing water on the floor around the toilet that we notified the sales office of. We suggest ensuring the carpet, baseboards, grout, etc are allowed to thoroughly dry and remedial action on these items as needed.

Water on hallway bathroom floor from bath tub (drain leak below tub?).

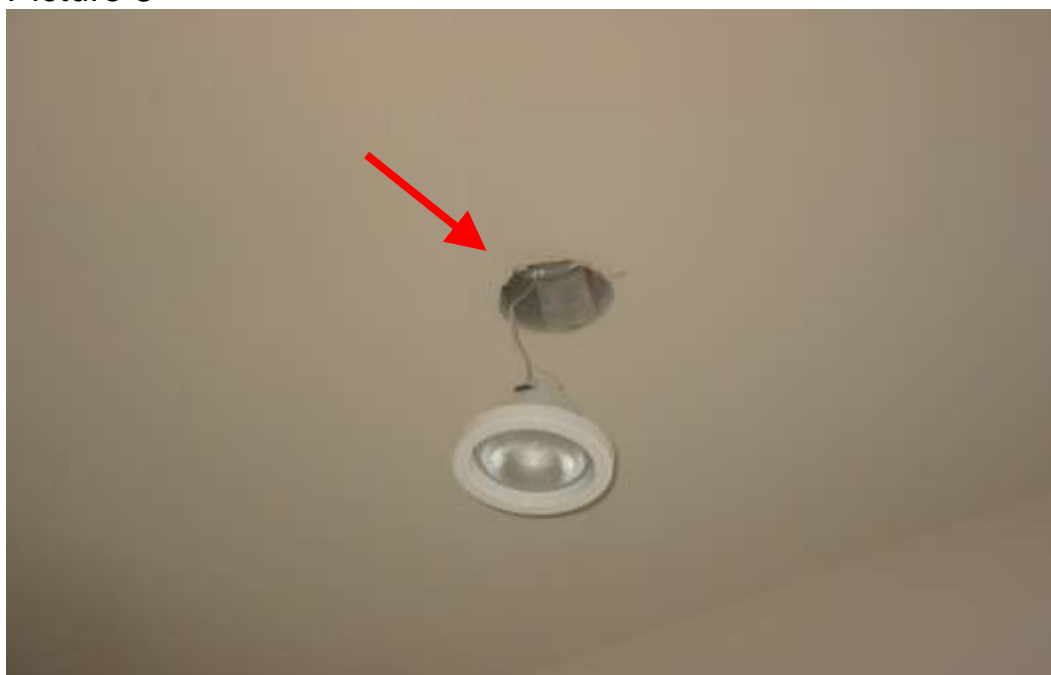
Picture 8

- The master bathroom tub faucet is loose.
- There is no seal installed in the corner of the glass panel/wall for the master bathroom shower stall.
- The light fixture inside the shower stall is hanging down from the ceiling (**See Picture 8**).

Light in master bathroom shower stall loose.
